## **CAP Inspection Log**

**Property Inspected:** Union Pacific Railroad Parcel B – Harbor Island, WA

**Date/Time of Inspection:** 28 December 2017, 0910-0915

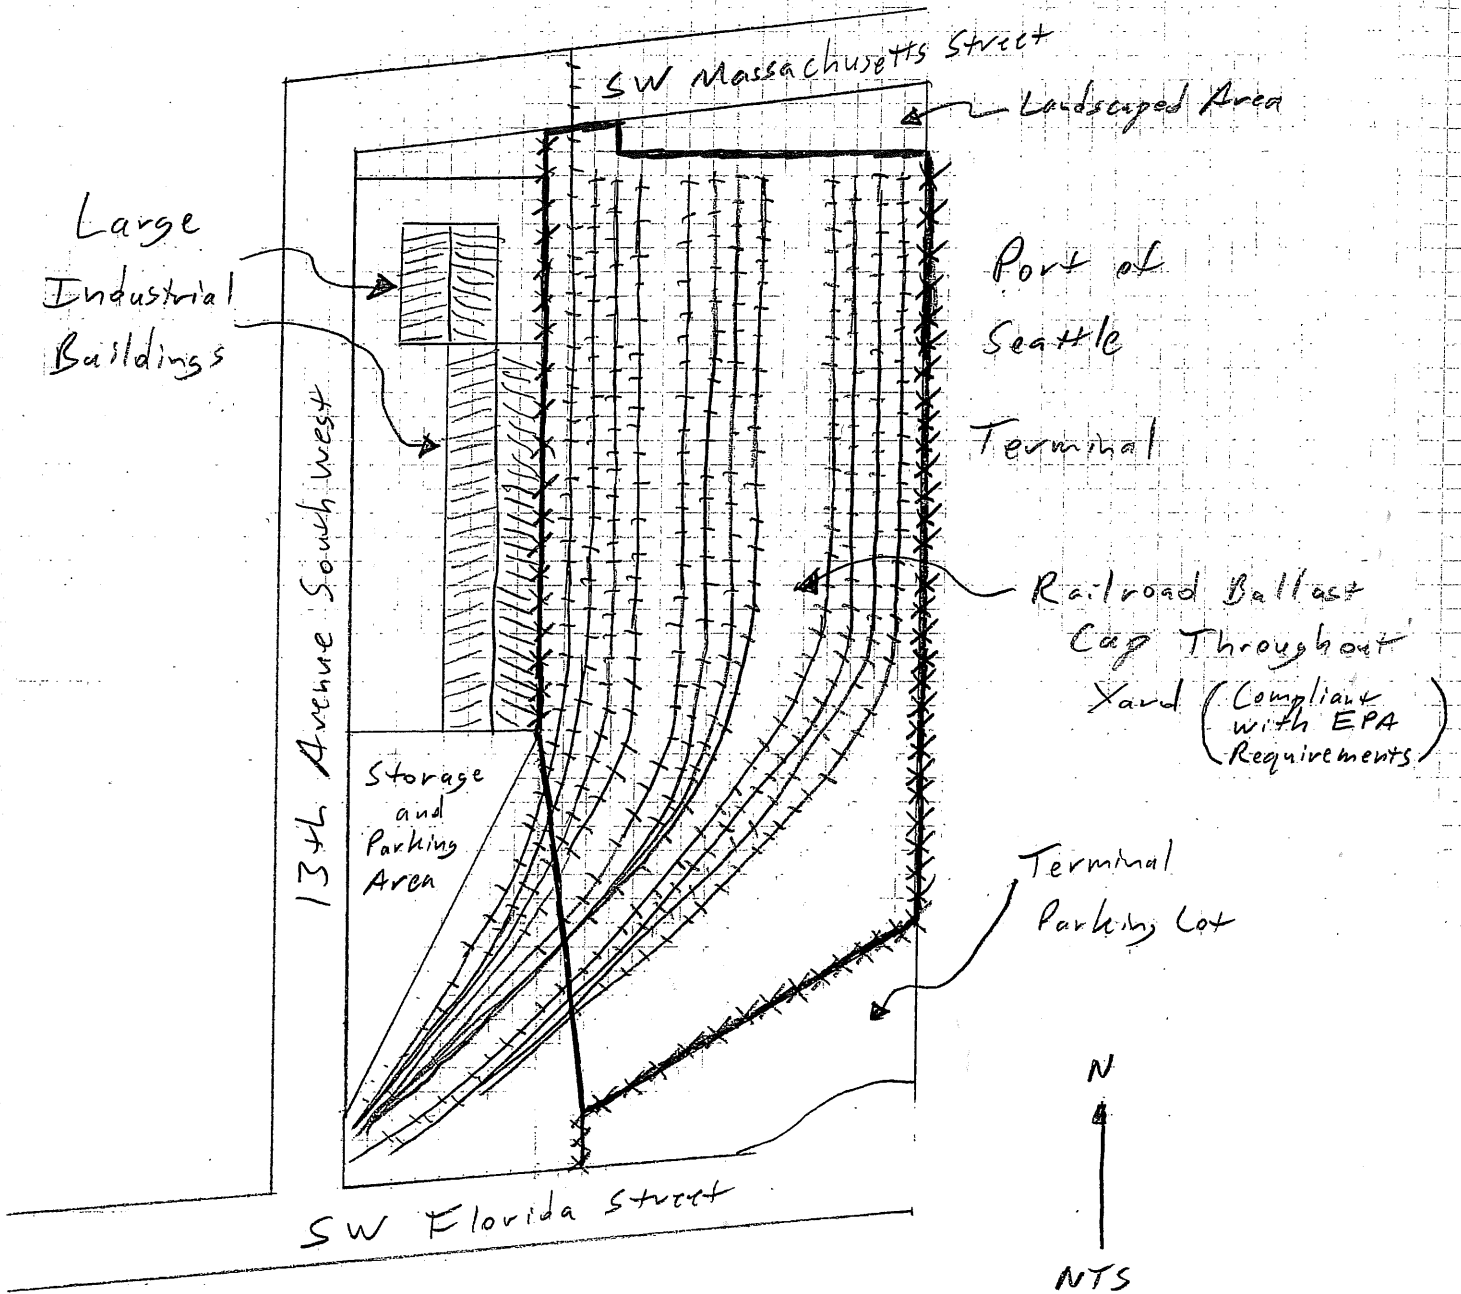
Figure 4 - Site Plan

**General:** The UPRR parcel observed is entirely capped with railroad ballast and is compliant with EPA requirements (see attached Figure 1 – Site Plan and attached photograph log).

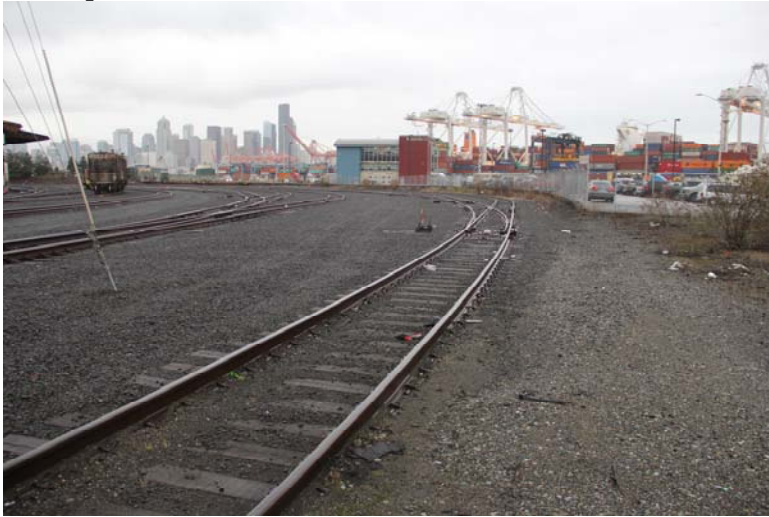
Photograph No. 1

Description: View near southwest corner of UPRR Parcel B. View is towards the north-northeast.

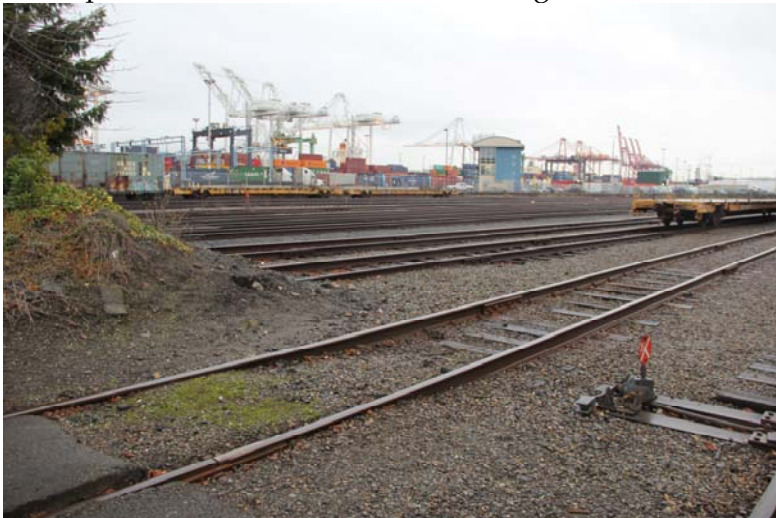
Photograph No. 2

Description: View from near northern edge of UPRR Parcel B looking towards the southeast.
